Addendum to Archeological Survey Report-Maritime Archaeology

(SFOBB)San Francisco-Oakland Bay Bridge East Span Seismic Safety Project

August 17, 2000

re: Addendum to SFOBB Archeological Survey Report-Maritime Archeology

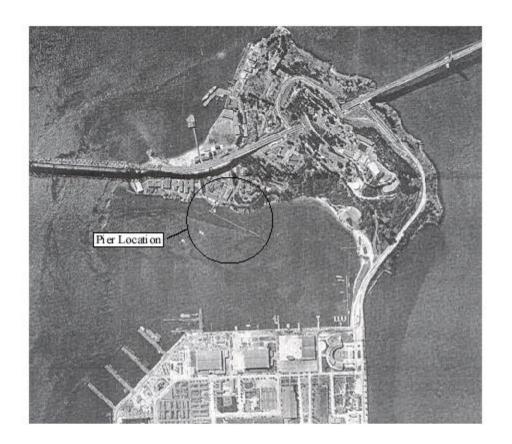
any acoustic evidence of their presence underwater, suggests that there are no submerged remains of the pier depicted in Photo 1. However, such remains may be present beneath the bottom sediments and not visible in the acoustic data collected during the survey. Although I consider it unlikely, the possibility

Clipper Cove, ca. 1945 (Photo courtesy of Caltrans, District 4) Photo 1 SFOBB East Span Seismic Safety Project

exists that remains of the pier may lie buried beneath the bottom sediments and I suggest that project subcontractors plan accordingly.

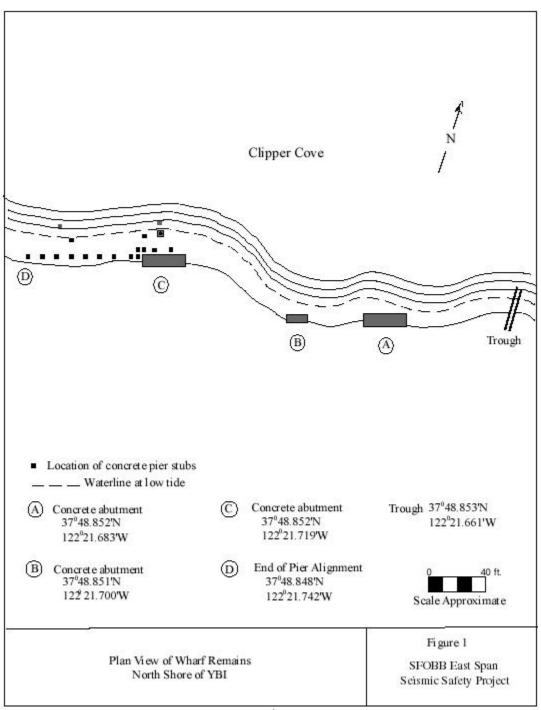
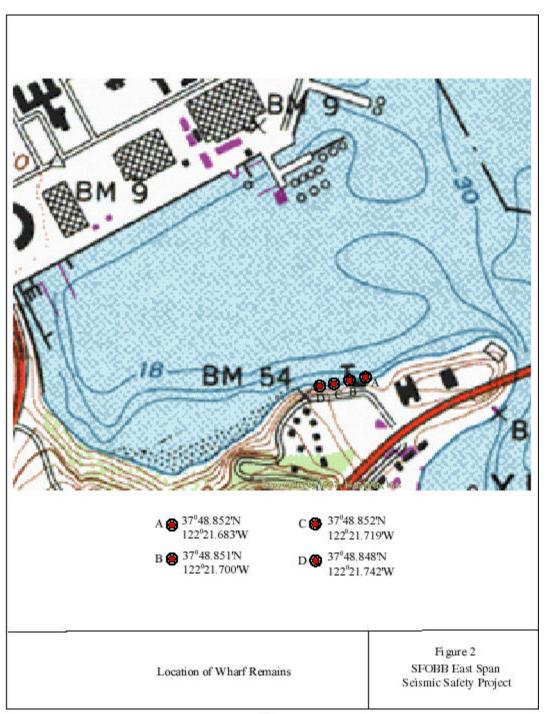
I am including a portion of the Oakland West 7.5 minute topographic quad as Figure 1. Depicted on the map are the locations of various elements of the pier feature as described in Figure 2, along with the corresponding latitude and longitude (NAD27).

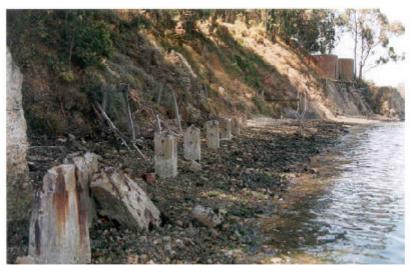
A pedestrian survey of the shoreline in the location of the former pier revealed the presence of three concrete abutments situated at the high water mark and a series of concrete pile stubs arrayed along the shoreline, parallel to the waterline (Figures 1 and 2; Photos 2 and 3). The pile stubs appeared to be approximately 24-inches square.

Photo 2: Concrete Pile Array. View West

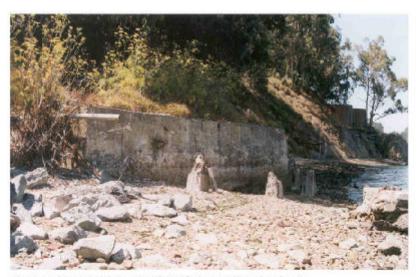
Photo 3: Concrete Abutment (One of Three). View Southwest

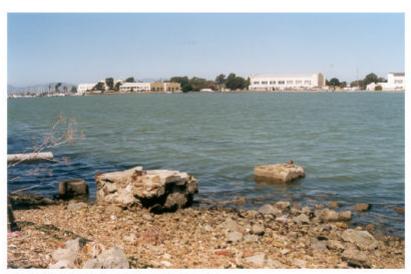
One square concrete block, larger than the concrete piers, was situated slightly offshore. An iron eyebolt or loop is embedded in its upper surface (Photo 4). As the survey was conducted during a period of low tide, it was possible to observe two submerged objects that may be the remains of two more concrete piers, although the marine growth covering them and their distance offshore obviated a positive identification (Photo 5). In addition, a narrow concrete trackway or trough was observed at the eastern end of the pier feature. Its ends extend into the water but from the shoreline it was not possible to determine to what extent (Photo 6).

Photo 4: Concrete Block. View Northwest

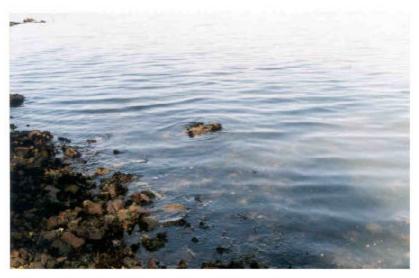
Photo 5: Possible Submerged Concrete Pile. View Northwest

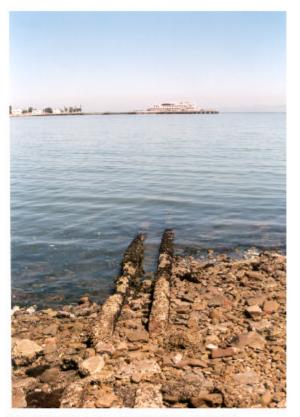
Photo 6

Concrete Trackway or Trough. View Northeast
